**SL8090/SL8091
SL8092/SL8093**

P1.0 Release4
(P1_0_0_8ap & P1_0_0_8bt)

Release Notes & Upgrading Instructions

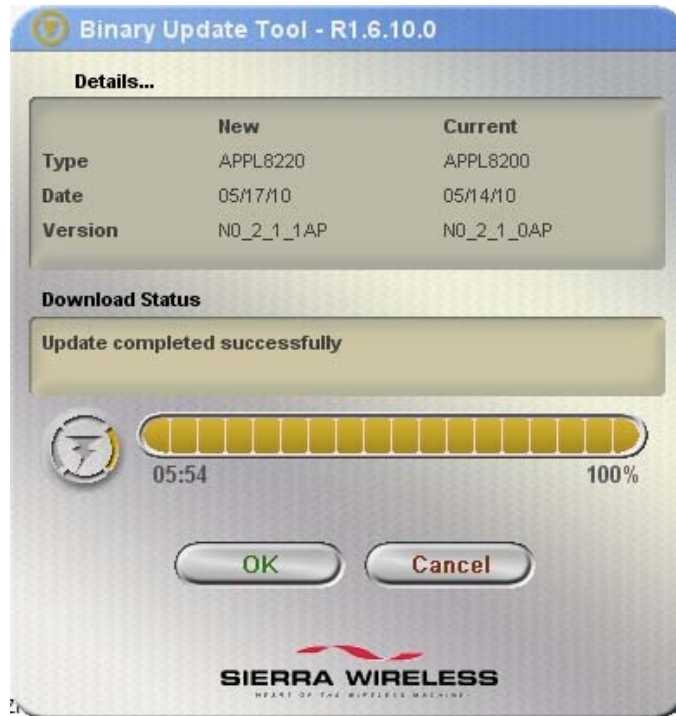
NOTE: The download can take up to 10 minutes to complete. Do not remove the power to either the laptop or the modem until the Binary Update Tool announces that the upgrade has been successful, as shown here:
